# Manhole Inspection Summary

Manhole # S17QQ1040MH

Insp Date: 11/14/06 10:37 AM

**Location** Address: **8 CORALBERRY CT**

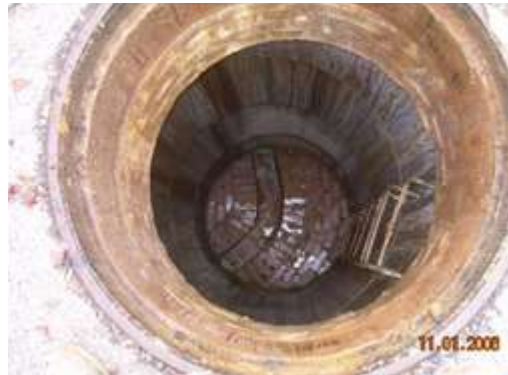
Top View

**Bench** ☒ Exists Material: **Brick** ☐ Parged ☒ **Debris** (not Condition related)

**Channel** Material: **Brick** ☐ Parged ☒ **Debris** (not Condition related)

**Surcharge** ☒ **Evidence Of Surcharge** Depth: **1** (ft.) ☐ Active Surcharge Present

Evidence of surcharge - Bench debris.  
Channel debris.

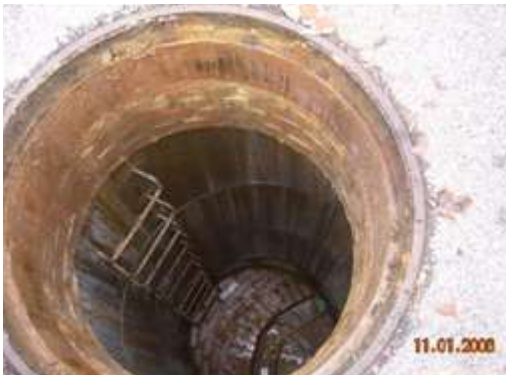
Defect

**Frame** Offset: **0** (in.) Condition: ☐ Sound ☐ Cracked ☒ **Leaks**

Condition: ☐ Sound ☐ Cracked ☐ Root Intrusion ☐ Loose Brick ☒ **Deteriorated**

Infiltration: ☐ None ☒ **Joint** ☐ Cracks ☒ **Mortar** ☐ Roots ☒ **Wall**

Infiltration: ☐ None ☒ **Joint** ☐ Cracks ☐ Mortar ☐ Roots ☐ Wall

Frame leaks. Adjustment deterioration  
and infiltration. Cobel infiltration.

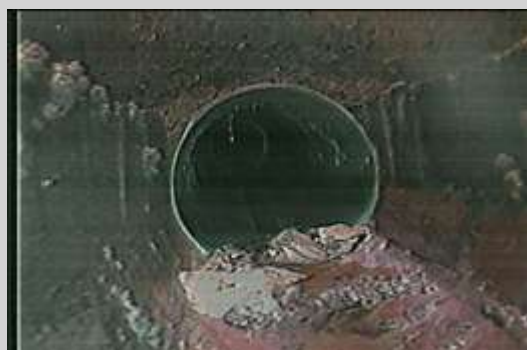
Pipe Out @ 12 O'Clock

Deposits: ☐ None ☒ **Mud** ☐ Sludge ☒ **Debris** ☐ Grease

Deposits Extent: **Light**

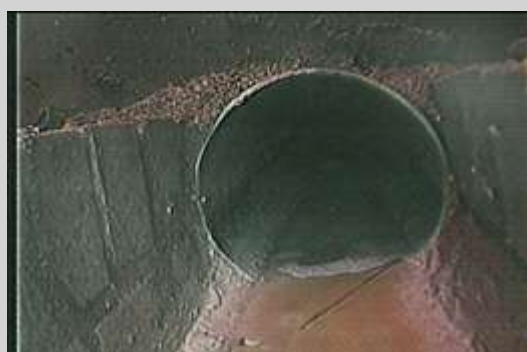
Pipe In @ 7 O'Clock

Deposits: ☐ None ☒ **Mud** ☐ Sludge ☒ **Debris** ☐ Grease

Silt Depth: **0.5** (in.)

Deposits Extent: **Light**
